# **The Ruins of the Gas Chambers: A Forensic Investigation of Crematoriums at Auschwitz I and Auschwitz-Birkenau**

Daniel Keren, Jamie McCarthy, and Harry W. Mazal

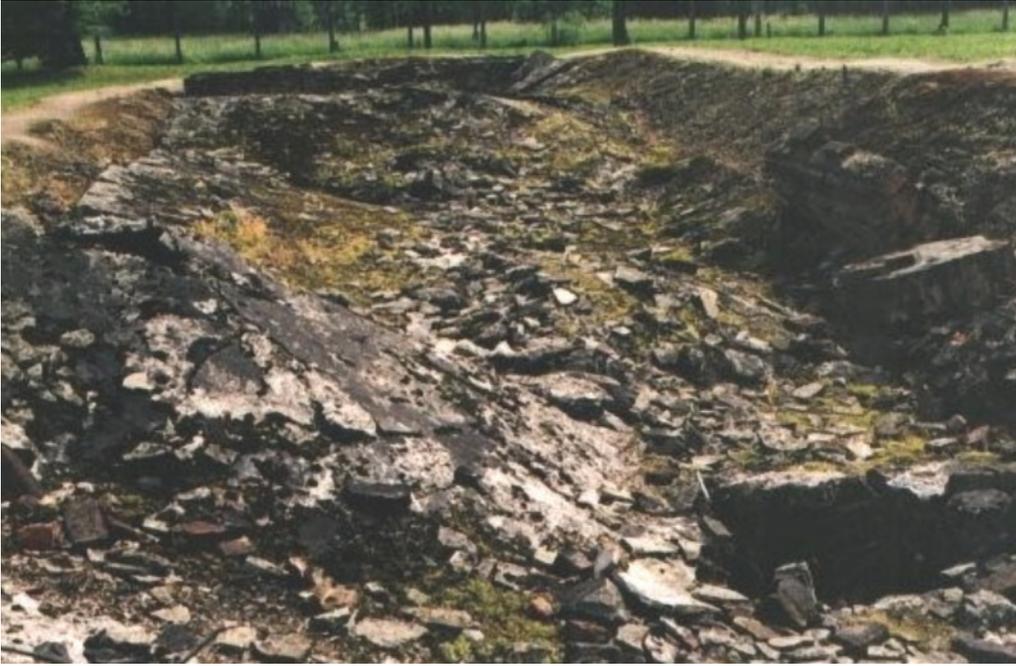
Figure 1b. Ruins of gas chamber in Crematorium II today.

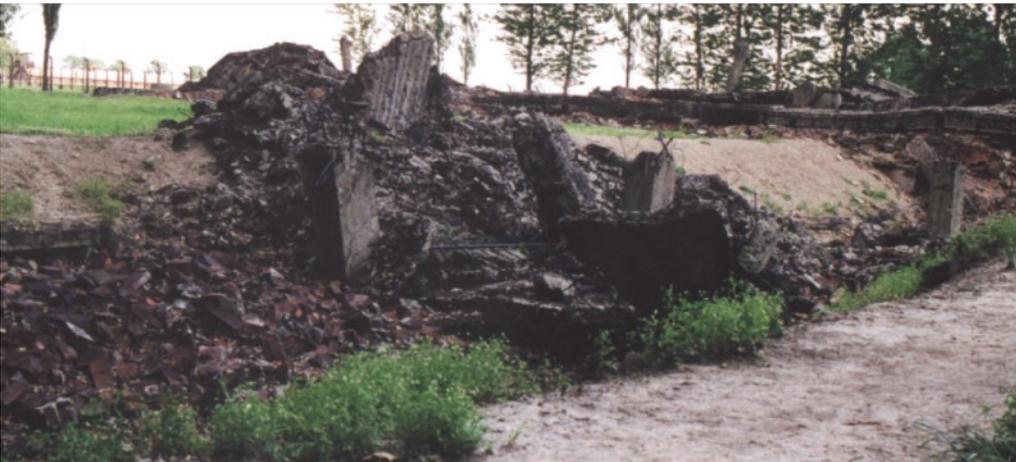
Figure 1c. Ruins of Crematorium III today.

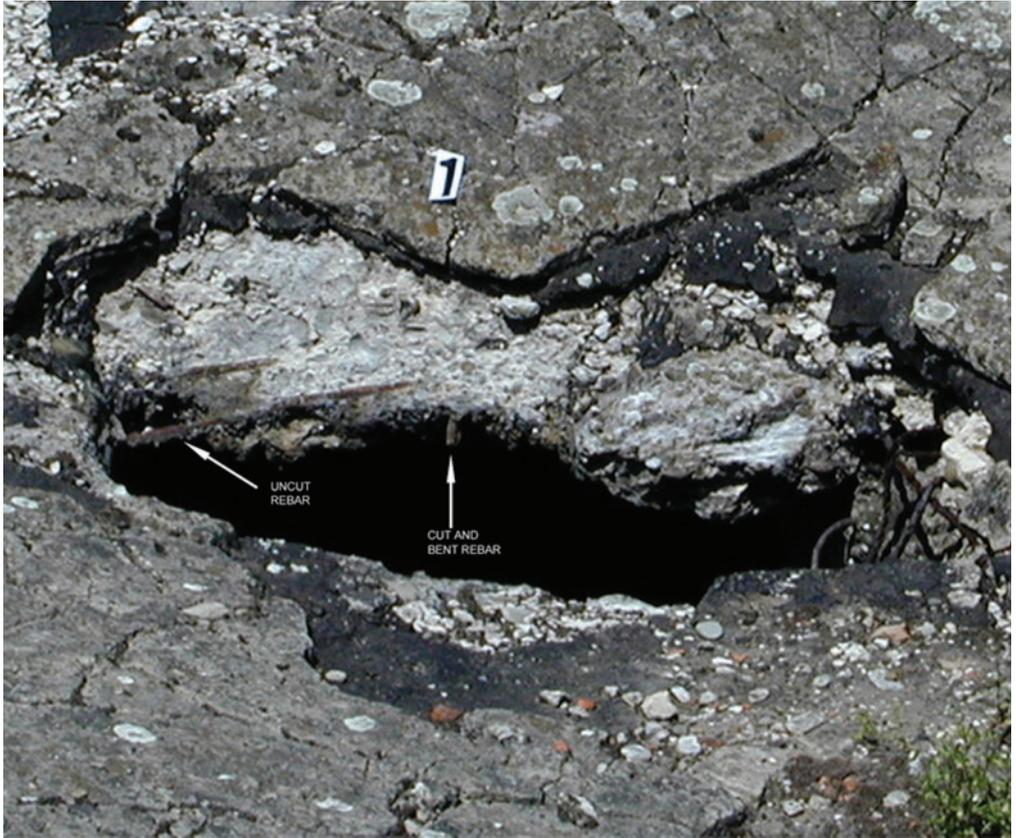
Figure 8b. Area of Zyklon Hole 1, Crematorium II. Tarpaper separating concrete layer below and sand-cement layer above is visible. South to north view.

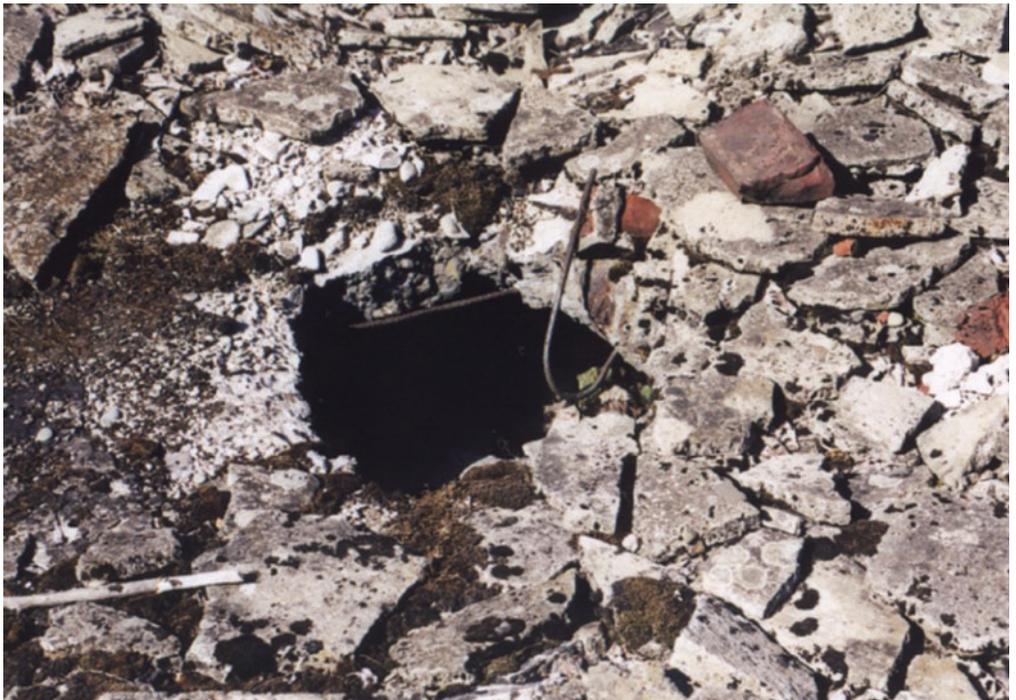
Figure 9. Hole cut for unknown purpose in Crematorium II roof, likely after liberation in January 1945.

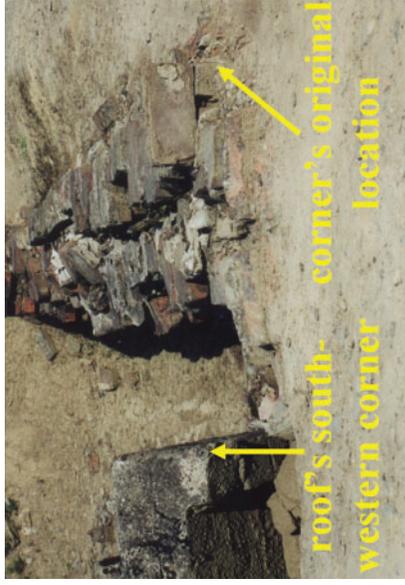
Figure 10a. West-east view of southern edge of Crematorium II gas chamber. Note how roof detached, shifted north, and tipped into hole (for comparison, brick length 23 cm). The shift left the first Zyklon hole farther north relative to first (southernmost) support pillar.

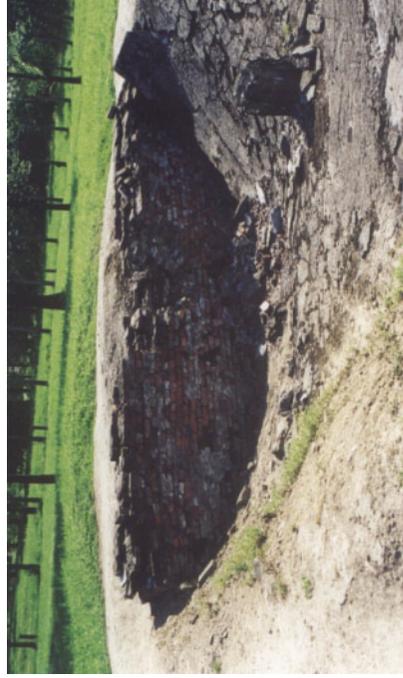
Figure 10b. Northeast-southwest view. Broken top of first support pillar pierces fallen roof.

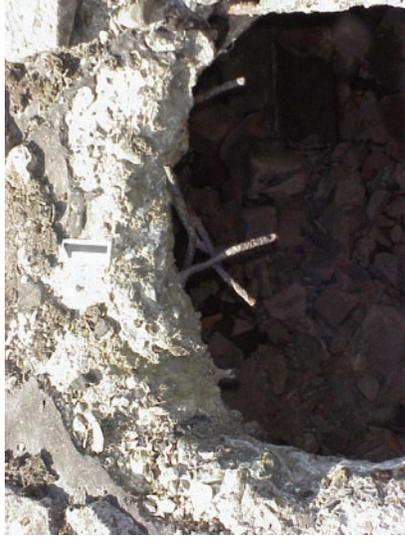
this was not the case. Portions of straight, flat edges and a 90-degree angle survive intact, though most of the concrete around the edge was damaged by the explosion. The center of this hole is 4.1 m from the southern end of the roof slab, and 0.75 m west of the roof's center. We estimate its size at approximately 0.5 m square; this places its eastern edge at 0.3 m west of the west edge of the central support beam.

Figure 11a. First (southernmost) Zyklon hole, overview. Taken from east looking west. Observe square form, with no rebar present; although damaged in explosion, hole clearly visible.

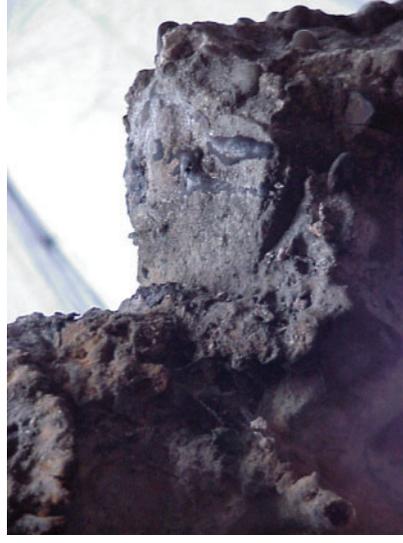
Figure 11b. First (southernmost) Zyklon hole, detail. Taken from below, showing residue of dripping tar. Surviving crawl space approx. three feet here.

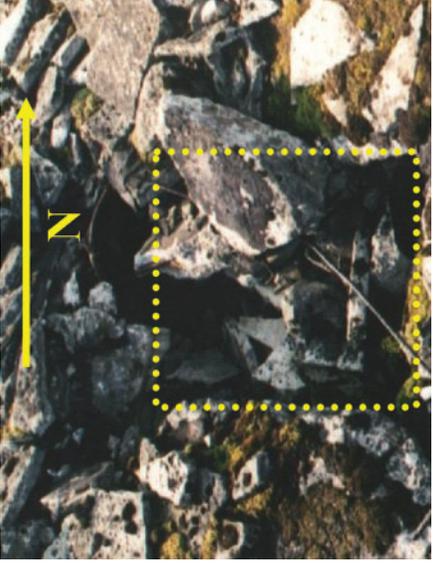
Figure 12. Second (from south) Zyklon hole, east to west view. Chunk of concrete torn away by explosion lies atop northern edge; western edge completely shattered. Outline of hole superimposed.

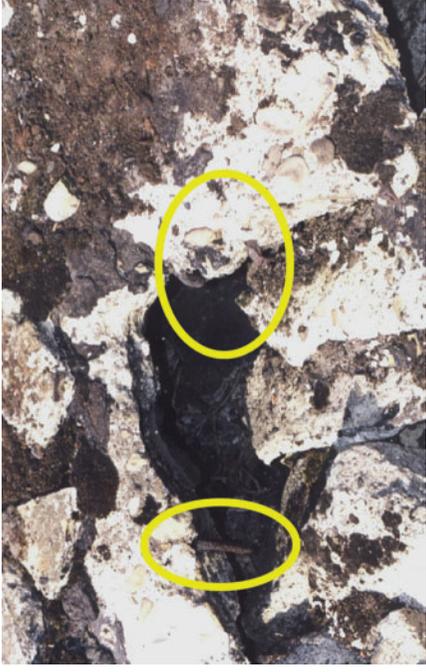
Figure 14. Inwardly bent rebar at north and east edges of second Zyklon hole, partially destroyed in explosion.

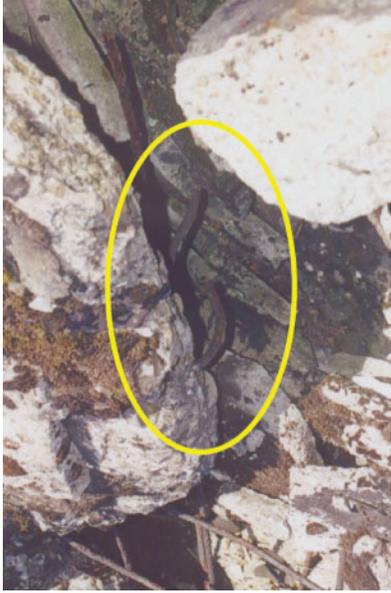
Figure 13. Straight edge and inward-bent rebar on southern side of second Zyklon hole. Such bending could not result from the explosion, which lifted the roof upwards.

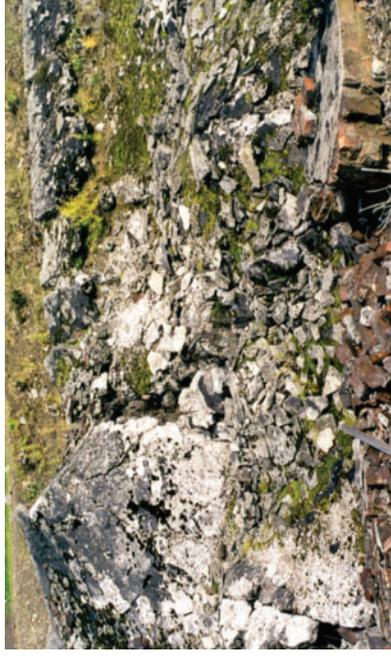
Hole 3's projected location is in an area of the roof that is badly damaged and covered with rubble (Figure 15). Preliminary research suggests that the hole itself may have been damaged when the roof collapsed on a portion of its own support structure. This hypothesis, however, requires further investigation. At the time this study was conducted, the researchers did not have permission to conduct the large-scale movement of rubble necessary to identify the third hole, but they are hopeful that permission may be forthcoming.

Figure 15. West-east view of hypothesized location of third Zyklon hole.

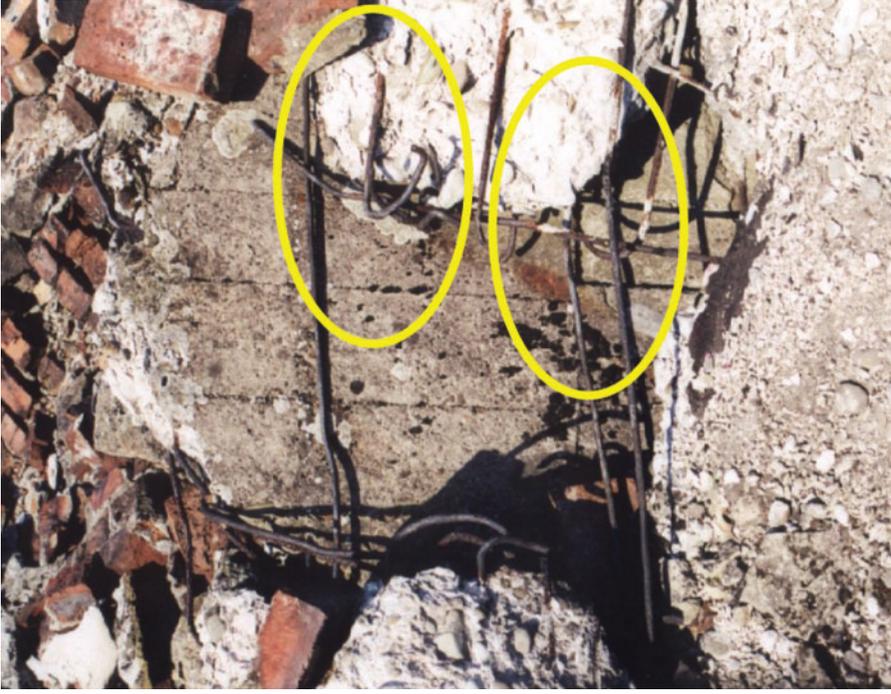
Figure 16. Remains of fourth (seen from south) Zyklon hole. Rebar skirts two sides, ends at other two sides bent inward and looped back. Note rotated roof slab showing formwork on inner side.

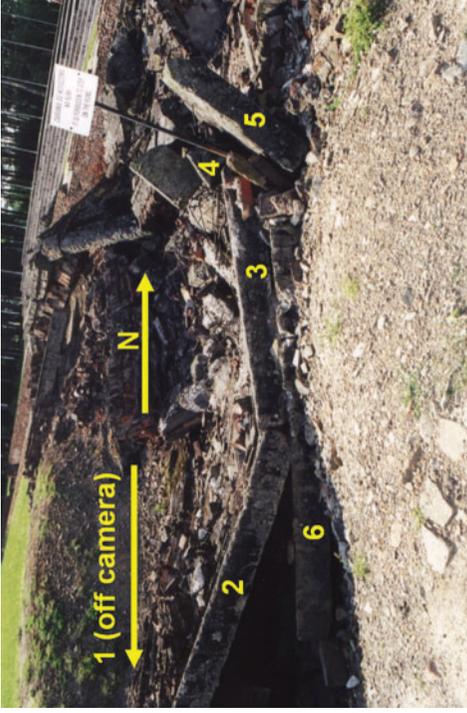
on the edge of this portion of the roof, the tar can still be seen, flowing, as it were, upward. Third, the upper part of “Section 6” (Figures 17 and 18) is the *inner* side of the roof, as seen in the imprint of the formwork. And fourth, the process of elimination: nothing resembling the missing northernmost roof slab (about 4 m in length) can be found anywhere else.

Figure 17. Close-up of fold area from eastern side. (Leaning sign on right is contemporary sign.)

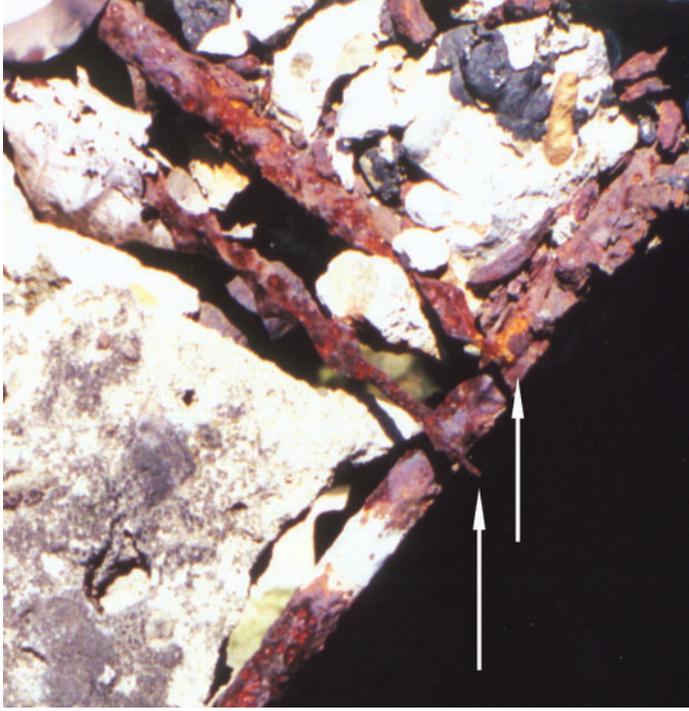
Figure 18b. Rebar stretched to a point at Zyklon hole 1, Crematorium II.

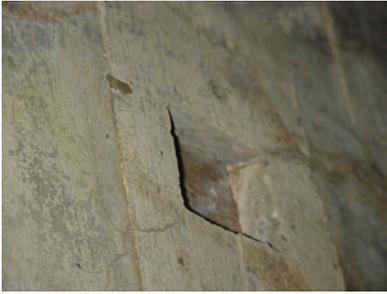
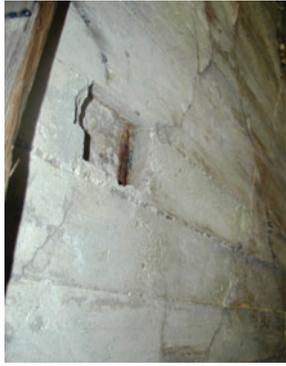
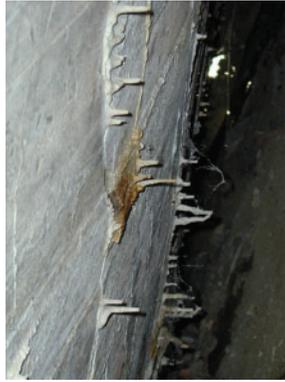
Figures 20a, b, and c. Three of the indentations in the gas chamber ceiling; in 20b (center), rusted rebar just touches inner edge; in 20c (bottom), wood block survives.

- i) A number of small (approximately 10×15×4 cm), rectangular cast indentations can be seen in the ceiling of the gas chamber. At least six of these are visible in those portions of the ceiling presently accessible from below. Some of the indentations have wooden blocks with visible rusted nails or screws. The indentations are uniformly placed and lined up on both sides of the support columns 2 m from the edge of the support beam, and extend from approximately 3 m north of the southern wall as far north as can be seen in the ruins. It is to the wooden blocks that fake showerheads reportedly were affixed (Figure 20).

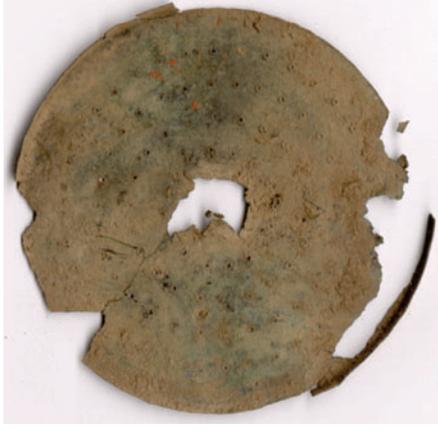
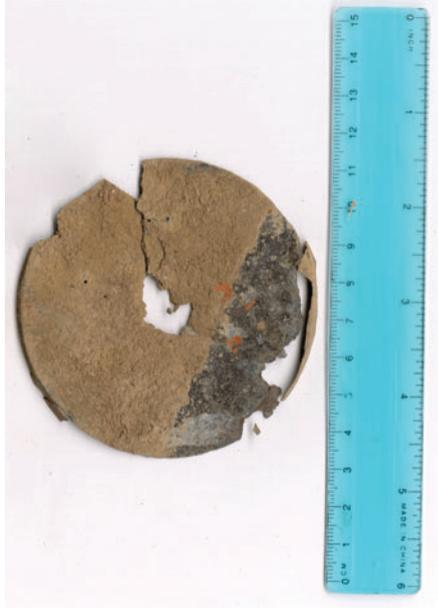
Figure 23. Front of probable false showerhead.

Figure 22. Rear of probable false showerhead found beside ruins of gas chamber of Crematorium II.

- k) We found a small disk 8 cm in diameter imbedded in the path less than one meter to the east of the gas chamber. The disk shows many small perforations (more readily seen on the reverse side) in a manner consistent with the front plate of a showerhead. The holes are of such a minuscule size—many

do not seem to perforate the plate at all—that it is unlikely that much, if any, water could have flowed through them (Figures 22 and 23). The sheet metal shows signs of having been galvanized, which would have inhibited rusting and made a “showerhead” more convincing. There is no evidence of any plumbing facilities in the gas chamber of Crematorium II. Given the convergence of evidence from eyewitnesses and documentation held in the archives of the Auschwitz Birkenau State Museum,<sup>18</sup> this fixture undoubtedly formed part of the elaborate plan to keep the victims ignorant of their fate as long as possible.

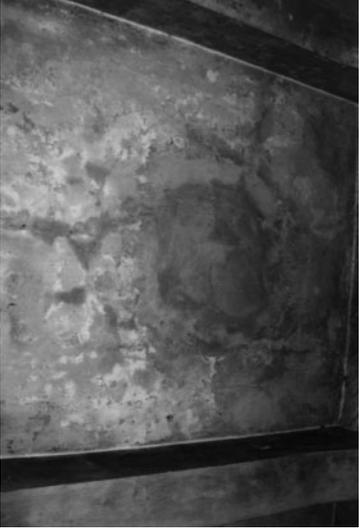
Figure 31. Sealed Zyklon hole Z1, which was not reopened during post-war restoration. Photograph taken inside chamber. It is not possible today to see the sealing signs on the roof, which was covered with heavy tarpaper.

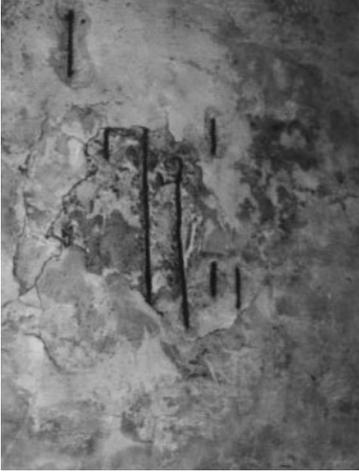
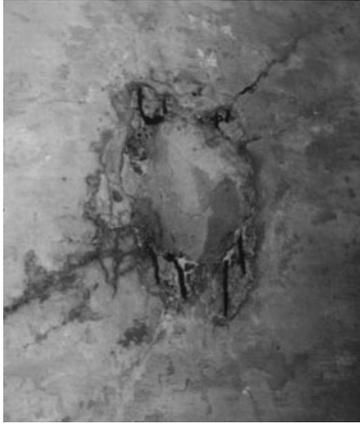
Figure 32b. Sealed ventilation openings in Crematorium I ceiling. It is not known why some rebar crosses opening.

Figure 32a. Sealed ventilation openings in Crematorium I ceiling. These openings housed circular vents used to replace the air in the gas chambers.
