No Holes? No Holocaust?

A Study of the Holes in the Roof of Leichenkeller I of Krematorium 2 at Birkenau

By Charles D. Provan

2001

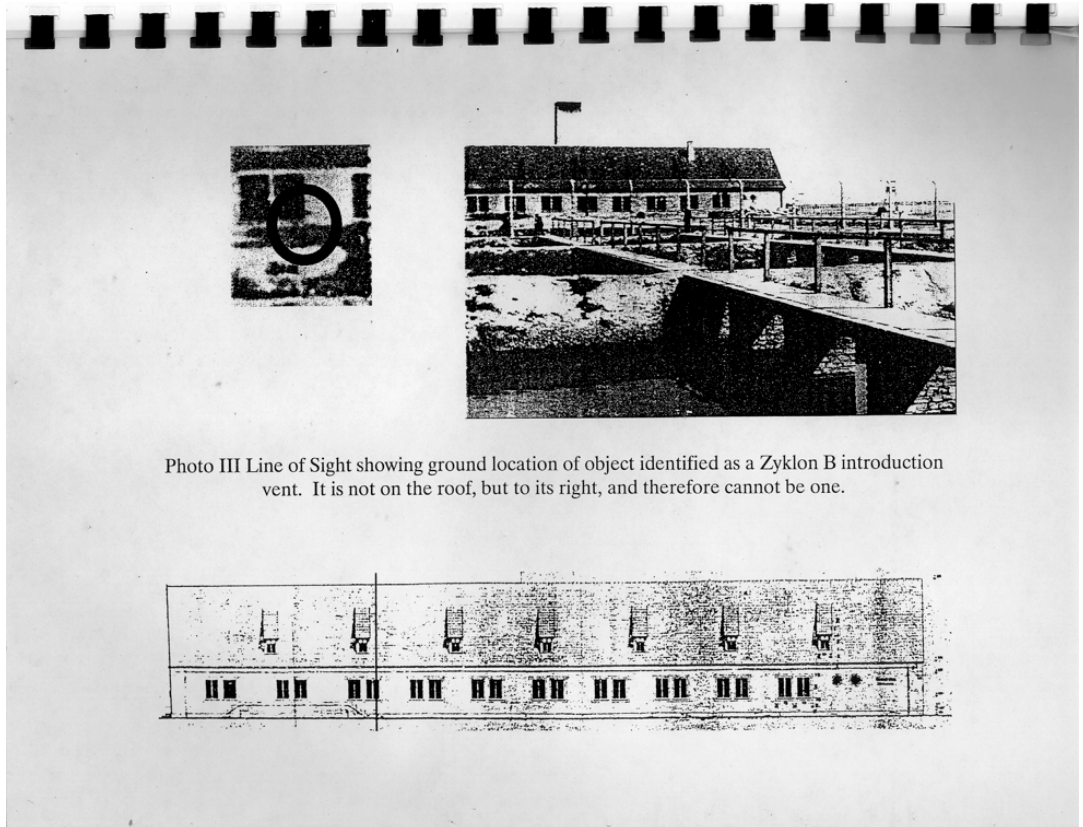
3. PMO neg. no. 20995 / 460 Kamann series [55]

This photograph was taken to show the sewage facility to the south of Krematorium 2, and thus shows the Krematorium and its leichenkeller in the photo background, from a southwest viewpoint. One may see the roof of Leichenkeller 1, and Pressac writes, "Just below the 7th double window of the furnace room is

the gas chamber with its Zyclon-B introduction chimneys scarcely visible." This writer cannot see anything on the roof except one vague object on the left side (thus, north side of the roof), and it is so blurry it can make no determination of what it is. So unless a better copy of this photo is produced, it doesn't make much of a proof, or a disproof, in common with the other photos examined.

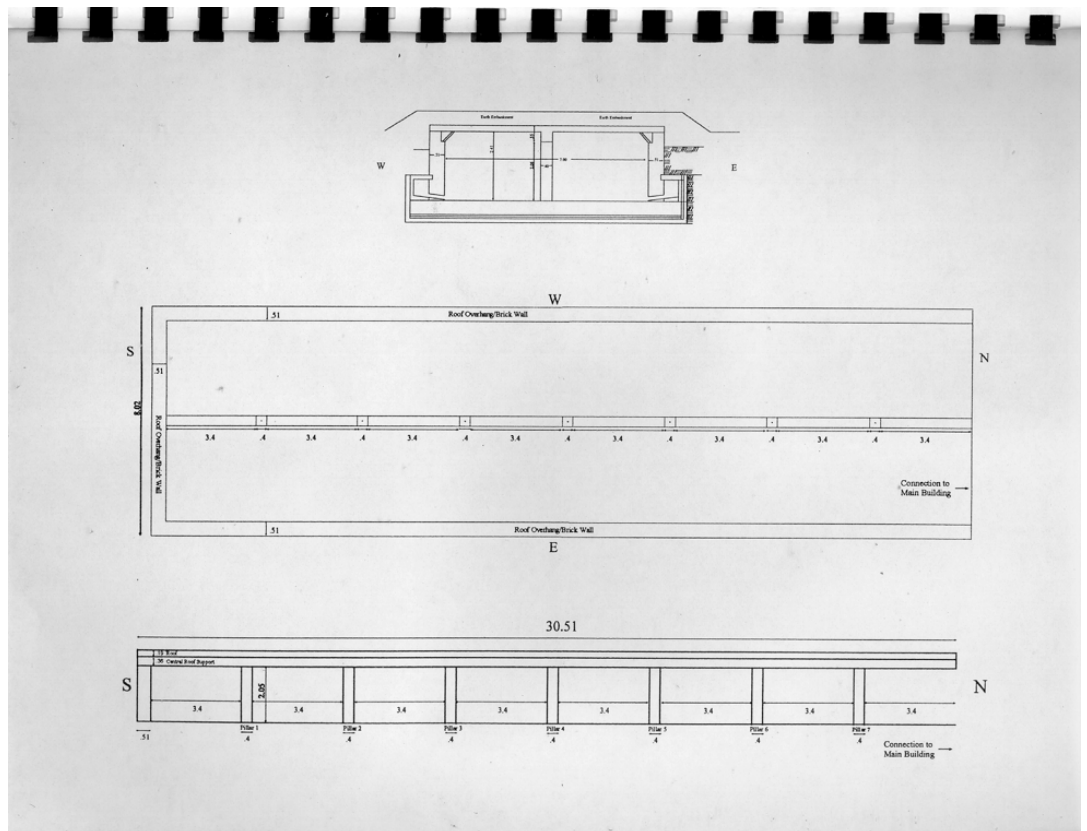
this statement, is correct. This author has walked on this ceiling myself with two others, and observed it to be quite sturdy even in areas where the holes are. For example, in the area of Pillar 1 are two large holes in close relationship to each other. One hole measures about 45 cm squared [65]; while the other, diagonally northwest across the central roof beam from the first, measures about 89 cm. long and 52 cm. wide. Yet this roof supported three researchers in the immediate area with no problems at all. So the steel reinforced concrete roof is still strong after 55 years, even though it had holes some 25 cm. square during the war [66], and even though at present it has holes some four to six times larger than those. In spite of the fact that the roof in the area we walked had been blown off the supporting pillars in 1945, and had crashed back to earth after the explosion. In conclusion, then, knocking some holes 25 cm. square would not have damaged the integrity of the ceiling in any appreciable manner at all.

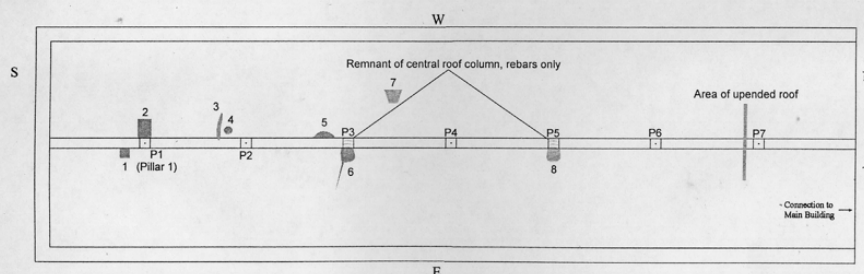
Present Holes in the Roof with the Roof Remounted and Flat

Drawing of building to scale; roof holes drawn in by hand.

Four holes is not only the vast majority report of the eyewitnesses who mention the number, but it also is the easiest to make sense of. For equal distribution of poison gas, the location of the insertion columns could easily be lined up **next to Pillars 1, 3, 5, and 7**. The gas effectiveness would not be affected by the building of a **brick wall in the middle** of the room, as **each half would be serviced by two poison insertion holes**, each with an equal area of killing.

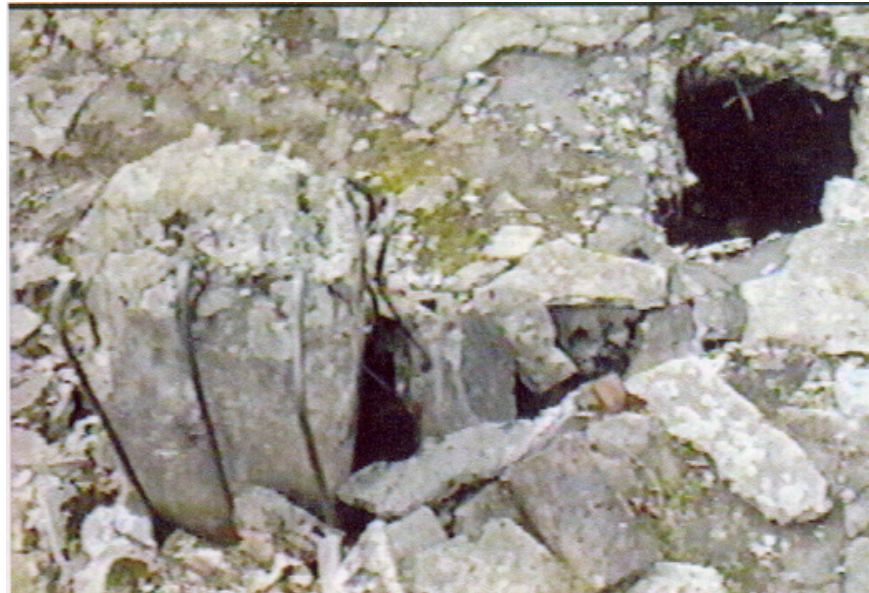
Pillar 1 (left, filling Hole 1) and Hole 2 (right). Note the large wide crack between the two. [View: from the east]

Starting at the southern end, we observed that **the roof in its present position is off-center, shifted to the north**. This would have been because when the Germans detonated the charges to blow off the roof [71], the roof **exploded upwards**,

but shifted to the north. When it crashed back down, the sides were upheld somewhat by the west and east brick walls, but the center, having missed the southern roof, crashed to basement level. **Locating the center, we made our first measurement along the center roof column,** from the southern edge of the roof to the next important object, Pillar 1. (The distance was 295 cm.) The roof had crashed downwards with such force that Pillar 1 pierced it on the eastern side of the central roof column, which lies flush to it on the west. (Pillar 1 was 40 cm. in thickness, from south to north.)

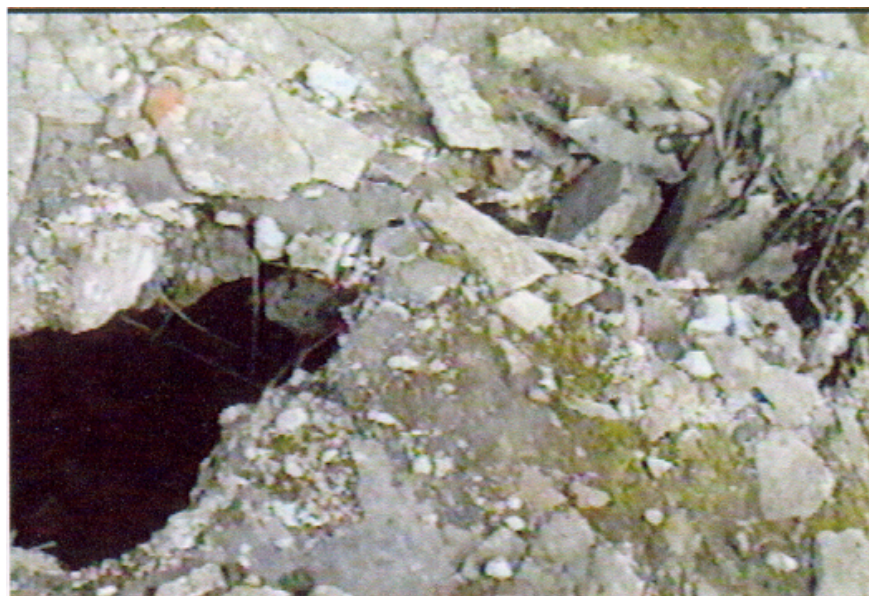
Hole 2 (left) and Pillar 1 (right), with the cracked area between. [View: from the west]

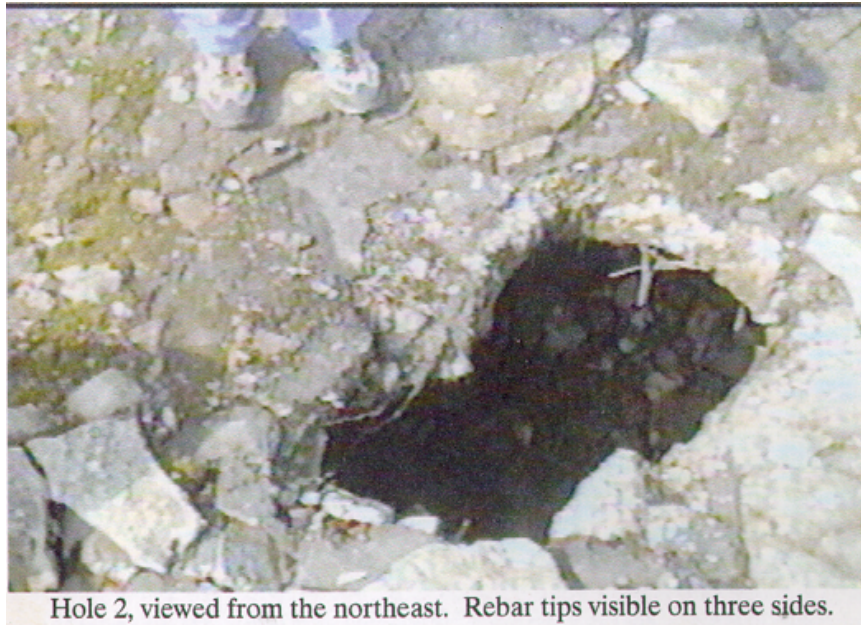
Hole 2, viewed from the northeast. Rebar tips visible on three sides.

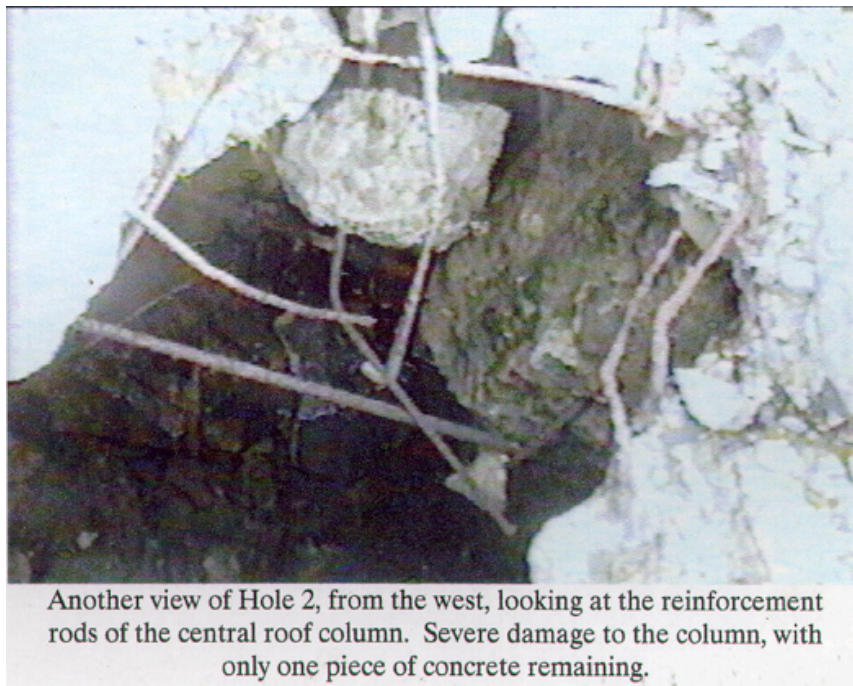
Another view of Hole 2, from the west, looking at the reinforcement rods of the central roof column. Severe damage to the column, with only one piece of concrete remaining.

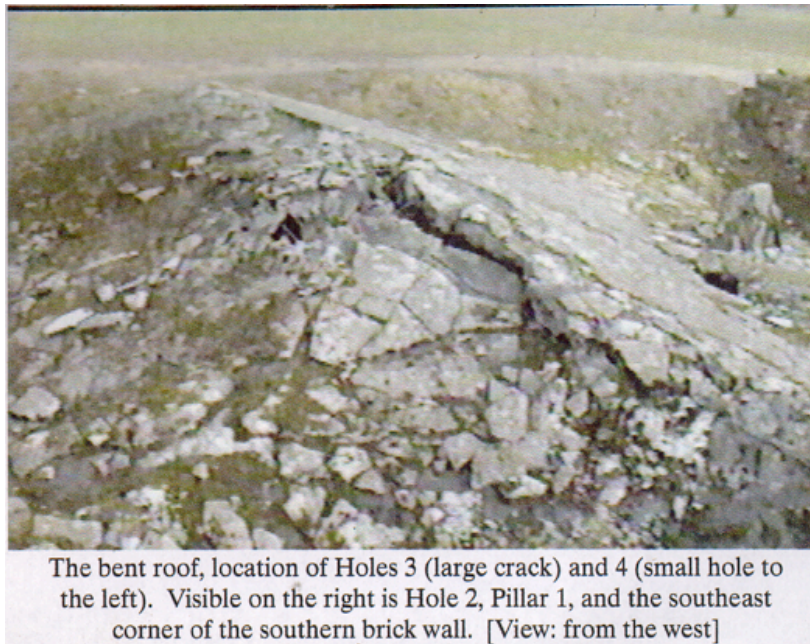
The bent roof, location of Holes 3 (large crack) and 4 (small hole to the left). Visible on the right is Hole 2, Pillar 1, and the southeast corner of the southern brick wall. [View: from the west]

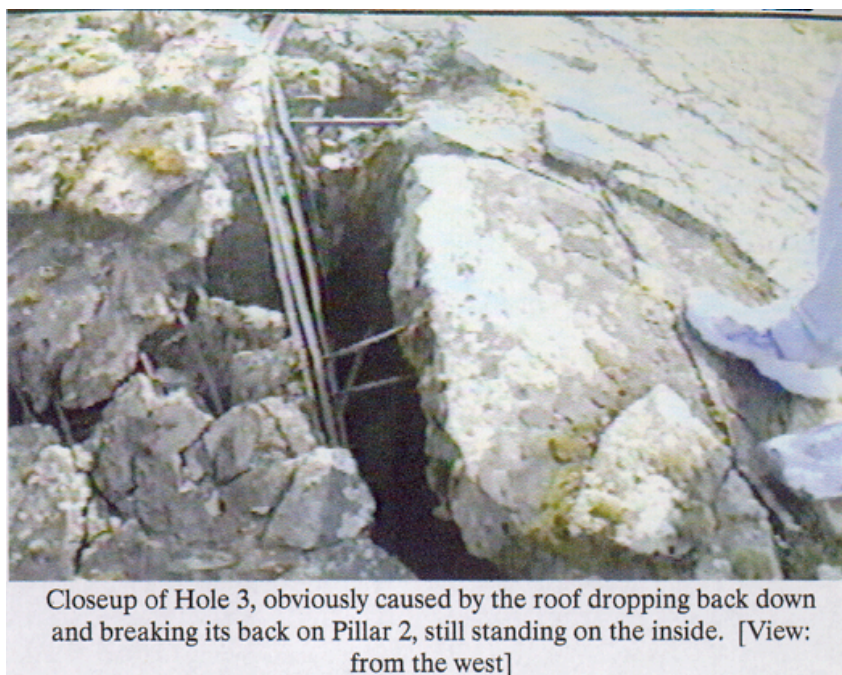
Closeup of Hole 3, obviously caused by the roof dropping back down and breaking its back on Pillar 2, still standing on the inside. [View: from the west]

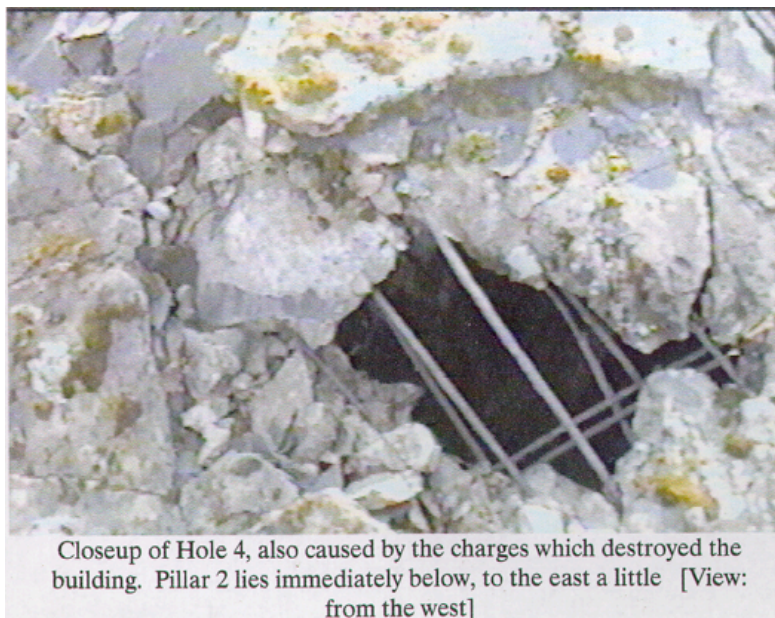
Closeup of Hole 4, also caused by the charges which destroyed the building. Pillar 2 lies immediately below, to the east a little [View: from the west]

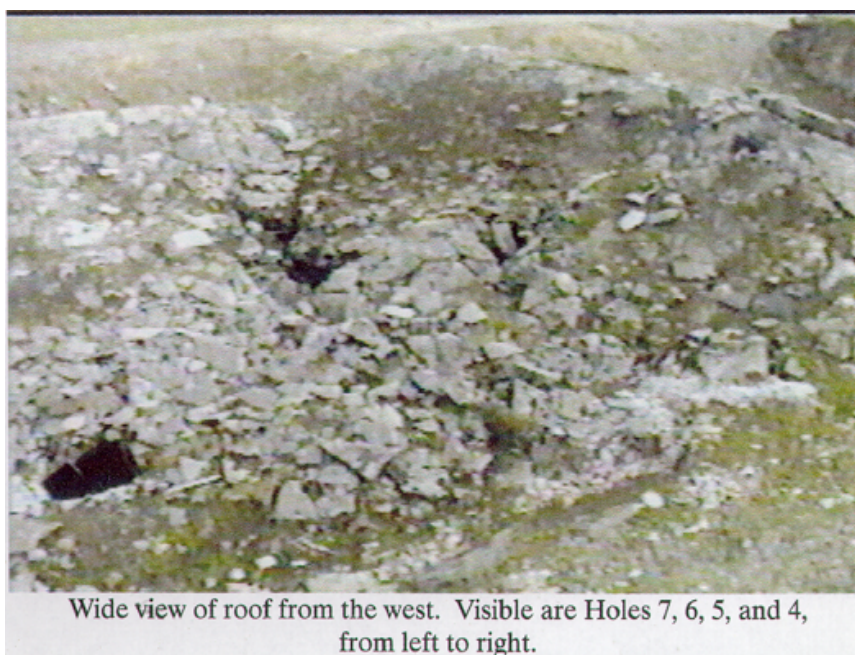
Wide view of roof from the west. Visible are Holes 7, 6, 5, and 4, from left to right.

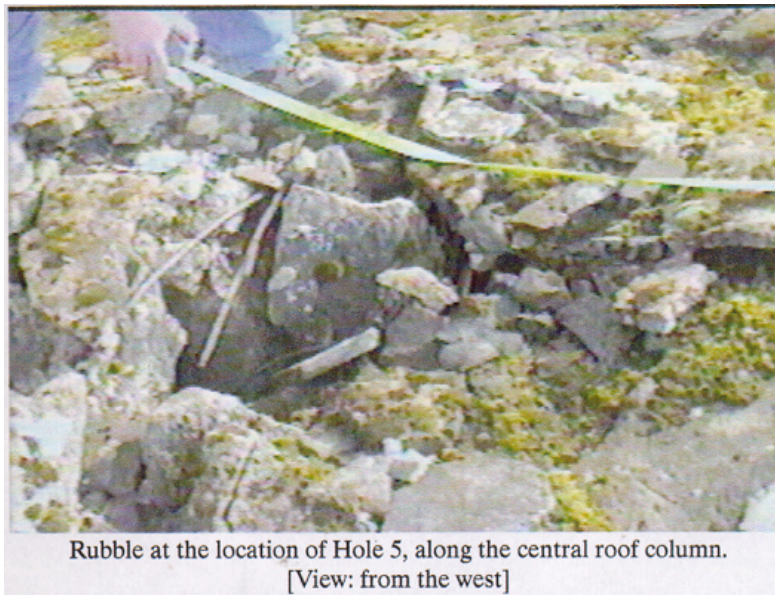
Rubble at the location of Hole 5, along the central roof column.
[View: from the west]

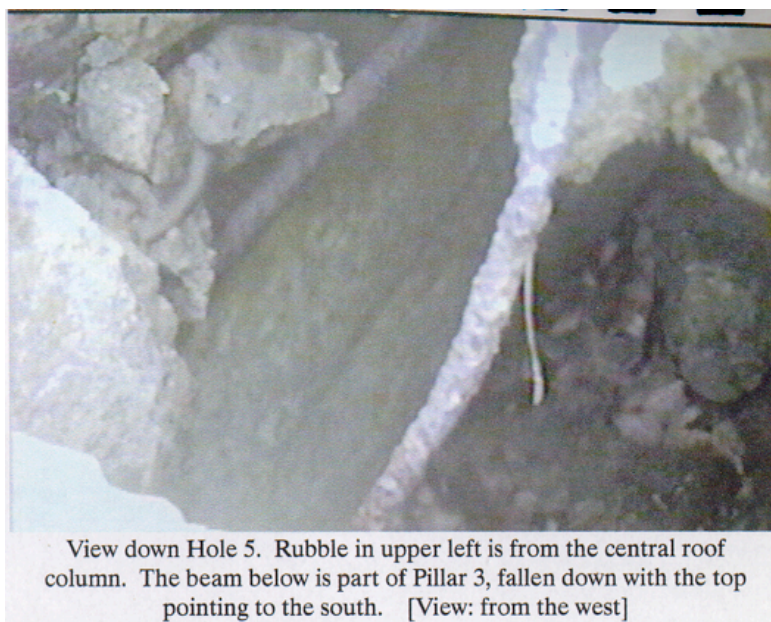
View down Hole 5. Rubble in upper left is from the central roof column. The beam below is part of Pillar 3, fallen down with the top pointing to the south. [View: from the west]

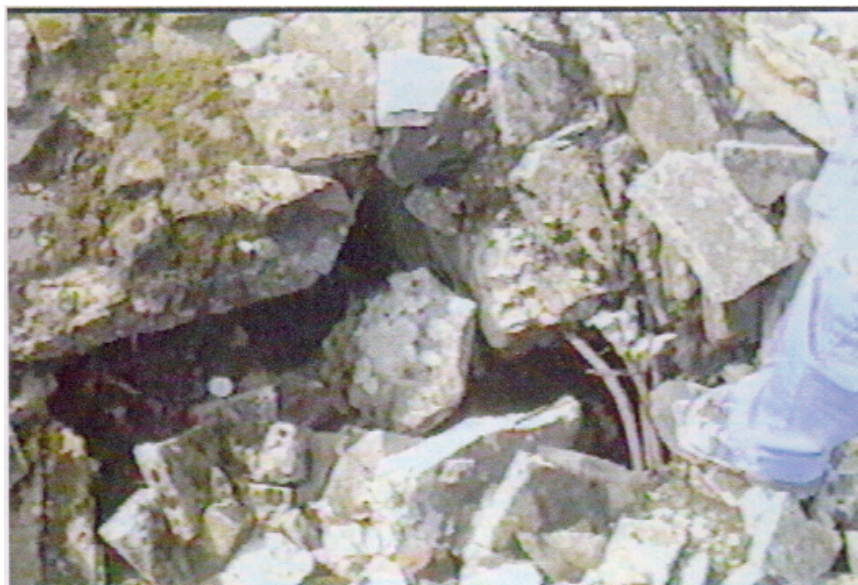
Hole 6. Writer is standing on the central roof column, shoes at the rebars of the same. Hole 6 is on the left. [View: from the north]

We consider it quite significant that Holes #6 and #8 were located immediately to the east of the central roof column, each of them right next to a supporting pillar (in these cases, Pillars 3 and 5). It should be noted that the central column to the west of both holes is destroyed, with only the rebars remaining. The roof above the reinforcement bars is also destroyed in both locations. Further, an enormously long crack extends to the east of Hole #6, which would have been located at Pillar 3. We think that the crack developed when the roof slammed downwards after hitting Pillar 2. The crack went right through the Zyklon B hole at Pillar 3.

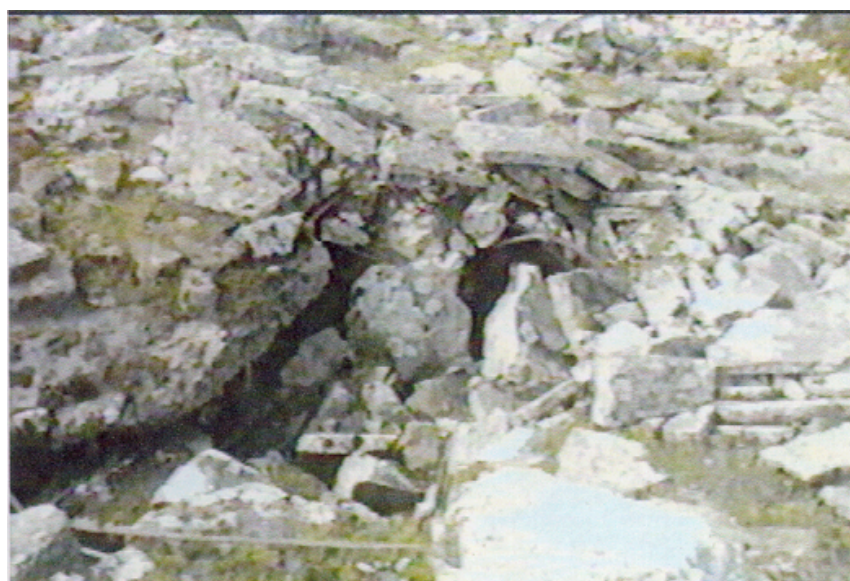
A wider view of Hole 6, showing the crack on the left, followed by Hole 6 and the central roof column rebars, from left to right. [View: from the northeast]

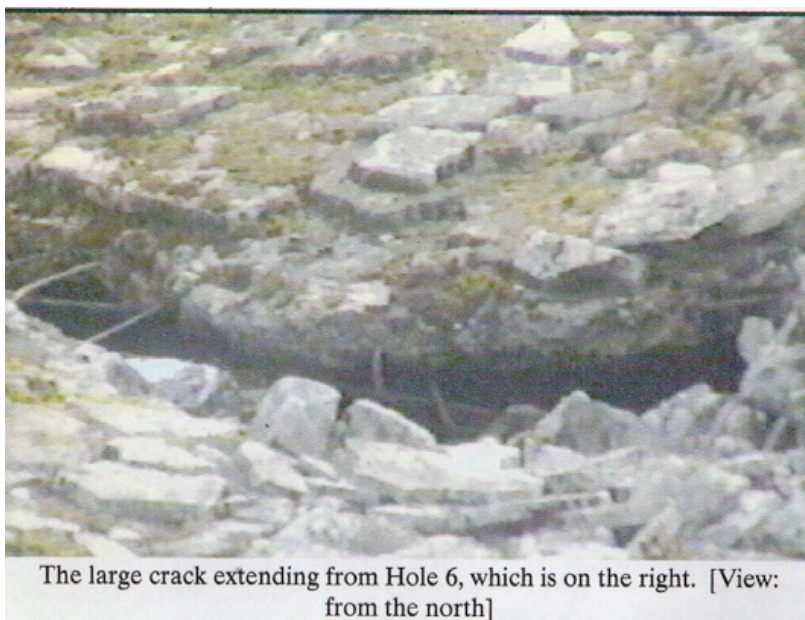
The large crack extending from Hole 6, which is on the right. [View: from the north]

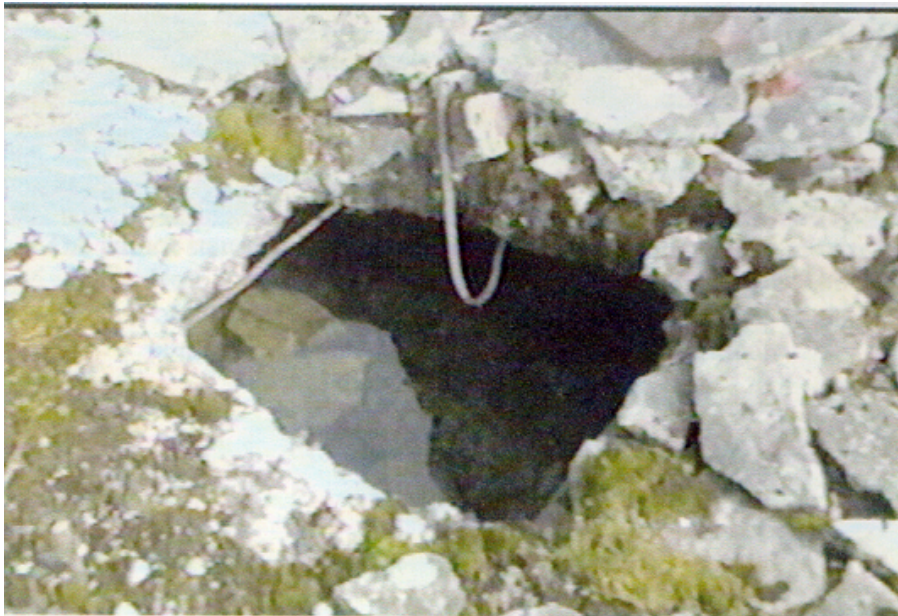
Hole 7, with only one rebar bent up. In the early 90's, there were more; all but one have been removed. This cannot have been a Zyklon B introduction hole. [View: from the west]

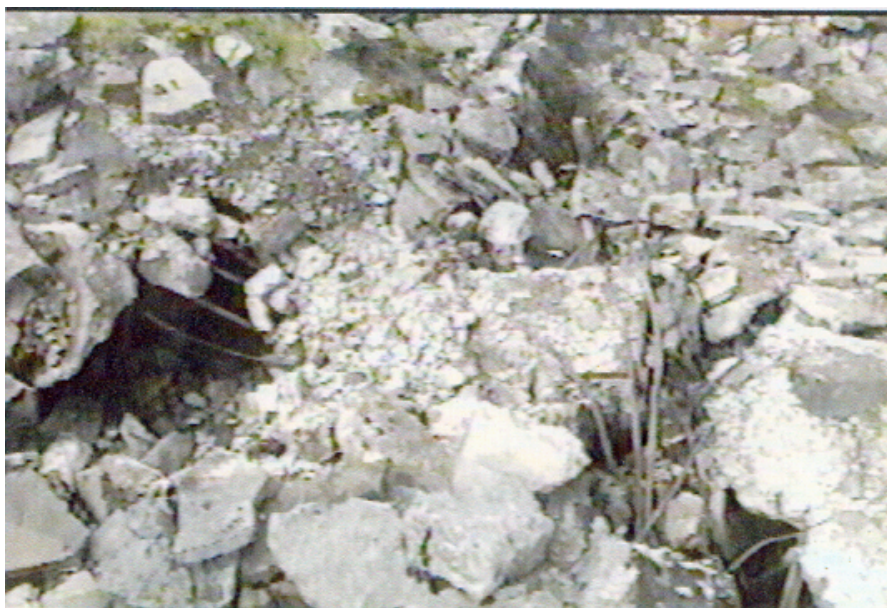
Hole 8, on left with rebar remnants of the central roof column visible immediately above. To the right, the shattered roof around the central roof column. [View: from the east]

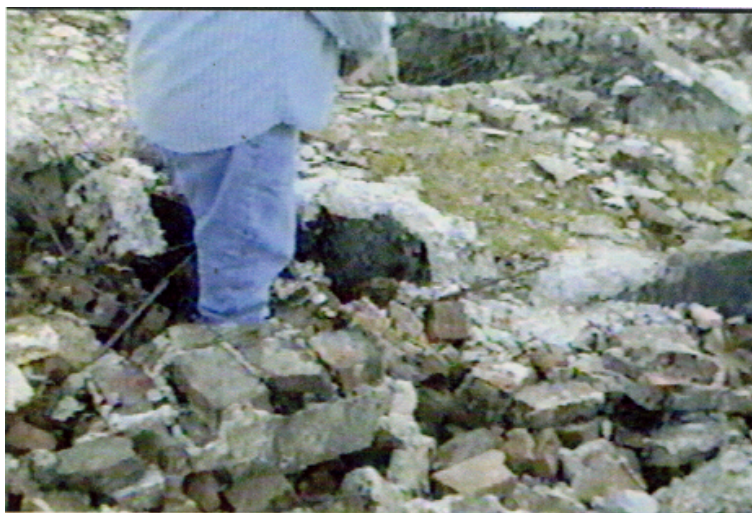
The author standing in the area where the top of Pillar 7 should have been. Note roof sections upended, with bricks to the north. The section of the roof we needed to check is under the surface, so the presence of a hole in this area could not be verified.
[View: from the north]

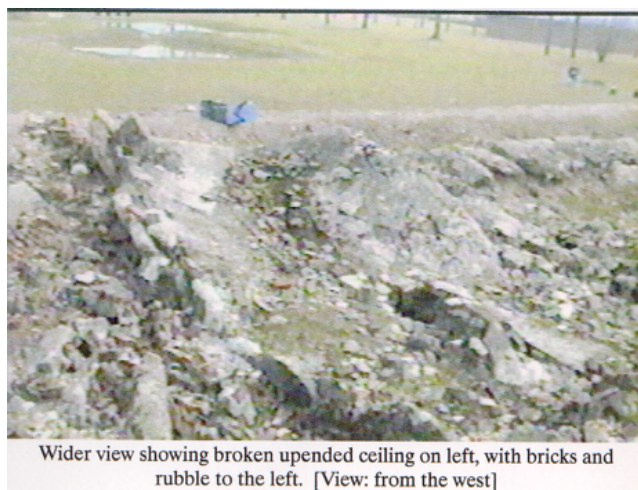
Wider view showing broken upended ceiling on left, with bricks and rubble to the left. [View: from the west]
