# **The Ruins of the Gas Chambers: A Forensic Investigation of Crematoriums at Auschwitz I and Auschwitz-Birkenau**

Daniel Keren, Jamie McCarthy, and Harry W. Mazal

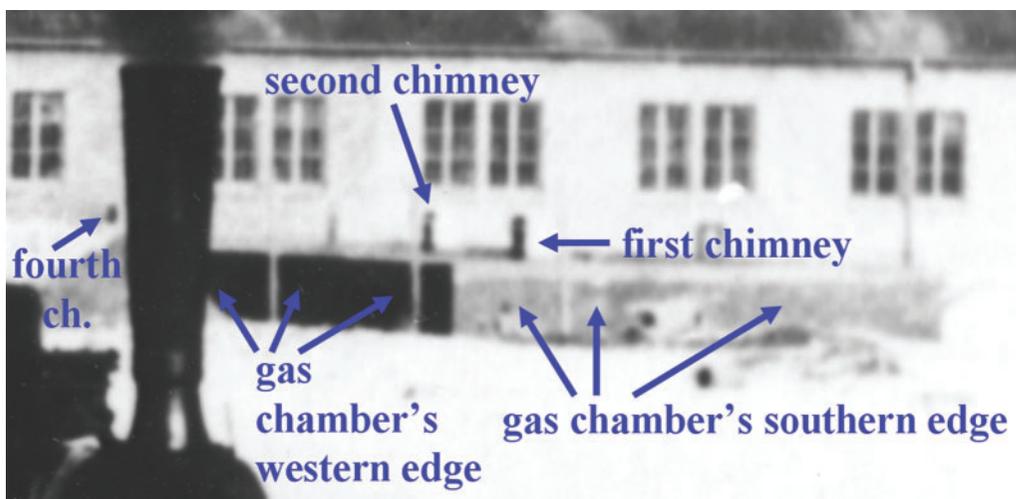
Figure 4. Detail of Figure 3. Third Zyklon "chimney" occluded by locomotive's smokestack. Photograph somewhat skewed (roof's edge slopes). After correction for skew, the three chimneys appear identical in height. Note also gas chamber semi-subterranean. Part of western edge obscured by camouflage earth embankment with triangular cross section (left of photograph), further discussed in Part III.

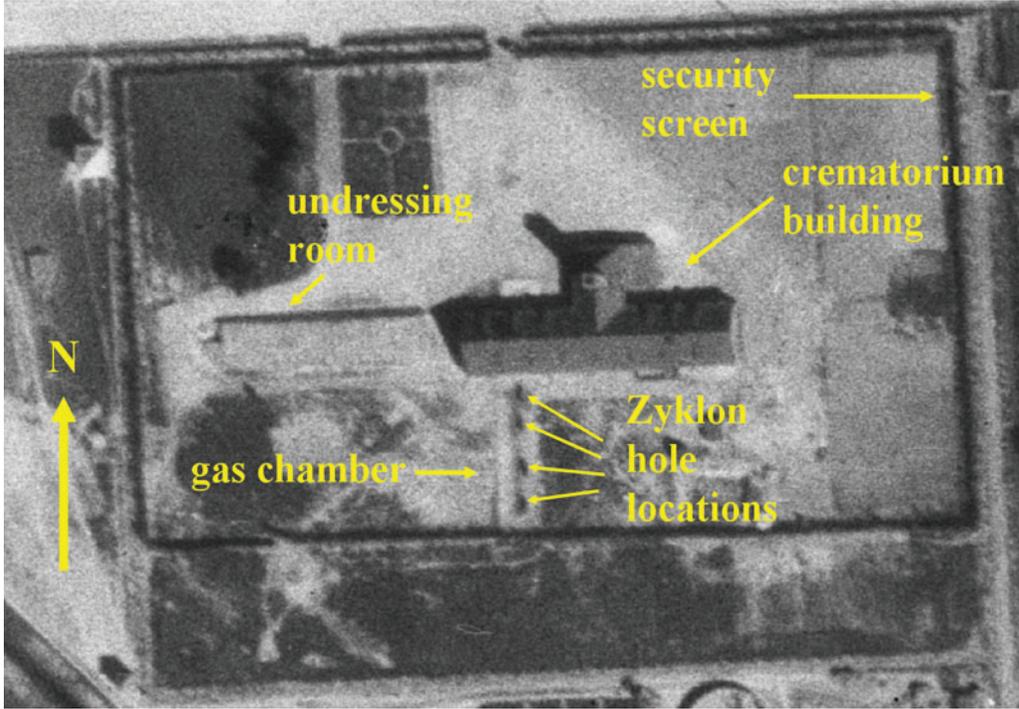
Figure 7. Detail of photograph of Crematorium II taken from American reconnaissance plane, August 25, 1944 ("August 25 Photo"). Heaped earth obscures east edge of gas chamber, making holes appear farther east. Holes alternate west-east-west-east (from south). National Archives and Records Administration (NARA), RG-373, Records of the Defense Intelligence Agency (DIA), Mission: 60PR/694 60 SQ; can. F5367, exposure 3186. Scale: 1/10,000; focal length: 12 inches; altitude: 30,000 feet.

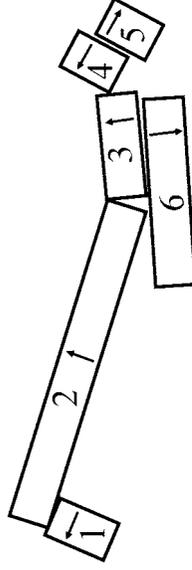
There is no question that part of the roof has folded underneath itself: that it is upside-down emerges from four observations. First, the rebar along the roof's north-south axis is still largely intact at the folds and can be observed running unbroken from the top portion of the roof, 180 degrees around, and through concrete into the bottom portion (i.e., between 3 and 6). Second, when the tar waterproofing was spread atop the concrete slab, it ran over the edge; the drips are visible to this day;

on the edge of this portion of the roof, the tar can still be seen, flowing, as it were, upward. Third, the upper part of “Section 6” (Figures 17 and 18) is the *inner* side of the roof, as seen in the imprint of the formwork. And fourth, the process of elimination: nothing resembling the missing northernmost roof slab (about 4 m in length) can be found anywhere else.

Figure 18a. How northern part of roof folded during explosion. Portion labeled 1 not in photograph. Fourth Zyklon hole 3 m west on portion 4. For exact scales see Figures 16 and 17. Eastern part of portion 4 shattered. Portions 5 and 6 were flipped over by the explosion (compare Figures 16, 17, and text).

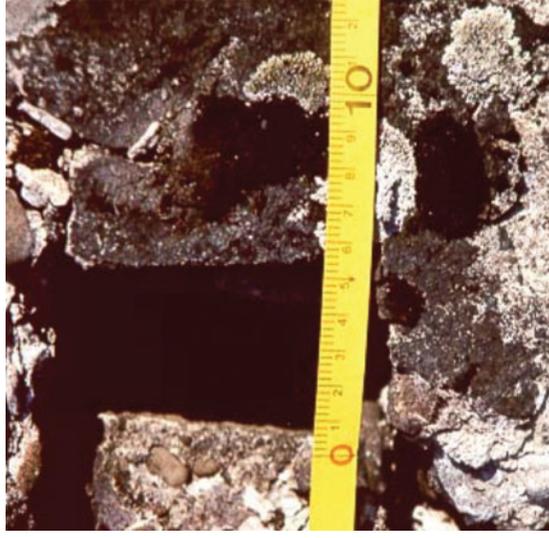
Figure 19. Cast aperture roof slab (centimeters).

- h) A small rectangular 4×10 cm aperture was cast at the same time, penetrating the roof into the chamber below (Figure 19). The aperture is 3 m north of column 5, and 2.65 m from the eastern edge of the roof slab. The function of this hole remains unknown. It was possibly fitted with a removable gasket

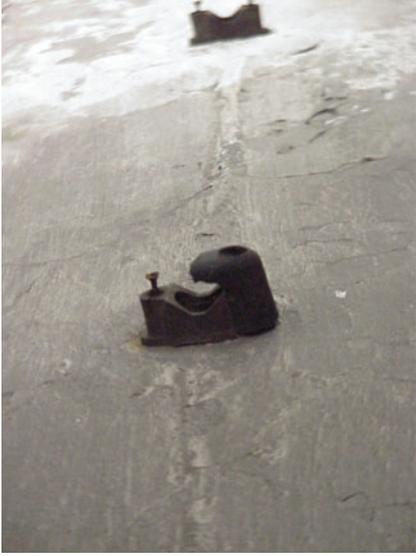
Figure 21. Bakelite supports on central support beam of Crematorium II.

- j) A large number of small wooden support blocks are attached to both sides of the central reinforced concrete beam. Several of these blocks still have attached to them small Bakelite plastic supports of the sort used to carry electric cable. The support blocks are visible all the way to the southern end of the support beam, some 2–3 m beyond the first showerhead block. Electric wires were most probably carried on these supports to provide current for illumination. Analogous supports in other parts of the concentration camp (e.g., Crematorium I) bear electrical cables (Figure 21).

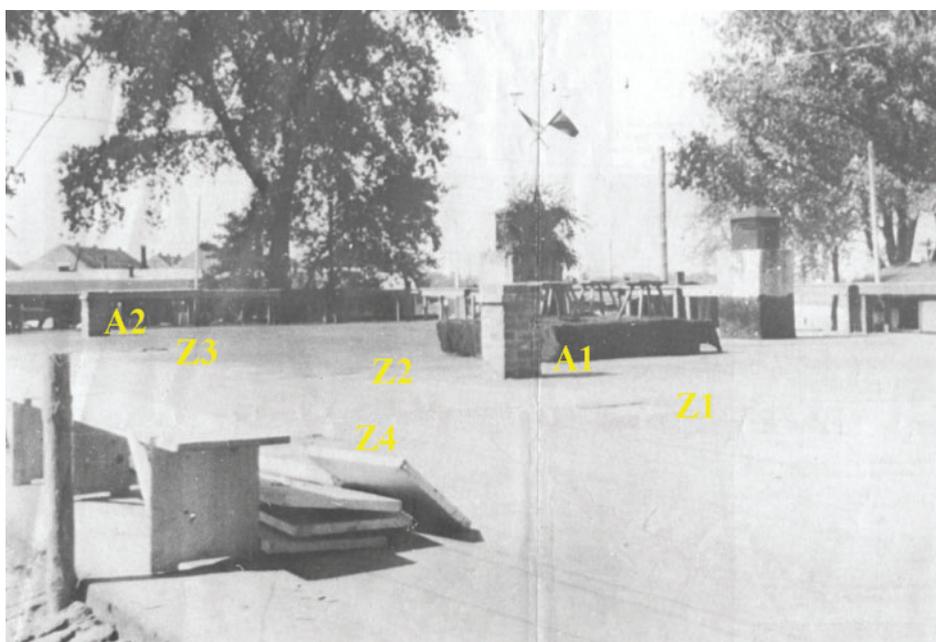
Figure 28a. Photograph of the Crematorium I roof ("pre-restoration photograph") taken before chamber restored (Auschwitz State Museum, Stanislaw Luczko Series, sygn. 5149). Z5 lies outside the picture (see Figures 30a and 33). Z1–Z4 easily identifiable by sealing marks.

It is easy to reconstruct the exact location of the Zyklon hole Z1 in the chamber’s interior: it lies at the intersection of the straight line connecting Z2 and Z3, and the straight line perpendicular to the roof’s longitudinal edge and passing through Z4 (see Figures 27 and 28). Exactly at this location there are clear signs of a square hole that was sealed (Figure 31). At two other locations holes were sealed, but these were circular ventilation openings (Figures 32a and b).<sup>28</sup>

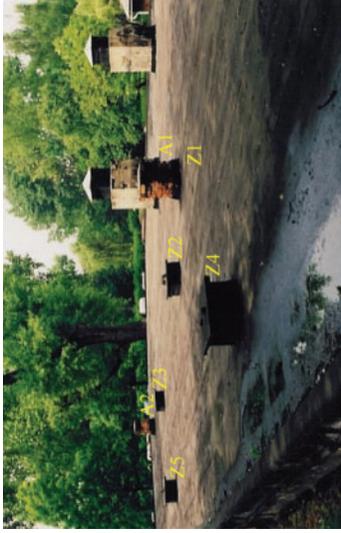
Figure 29. The roof today, with the same notations as Figures 27 and 28. Z1 was not reopened, but its location can be determined from Figure 28 and from measurement inside the chamber (see Figure 31 and relevant discussion).

The reader can see how the roof appears today in Figure 29. Figures 30a and b depict details from the current photograph (a) and the pre-restoration photograph (b) side by side.
